Home Inspection Report for:
Joshua & Jennifer Hennessy

Date:
Friday, February 20, 2015 Report #022015-01

Subject Property:
5150 Kiawe St, 208 B, Princeville, HI 96722

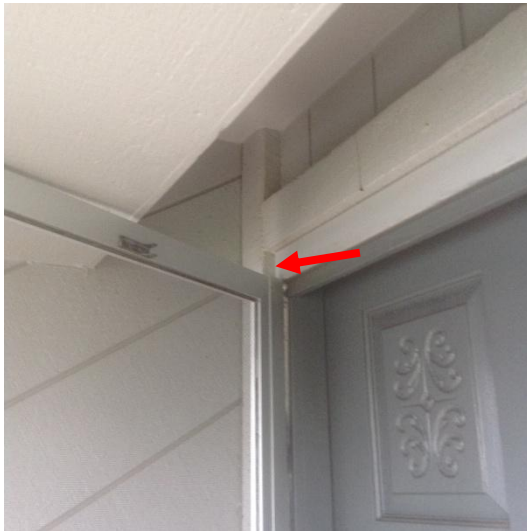
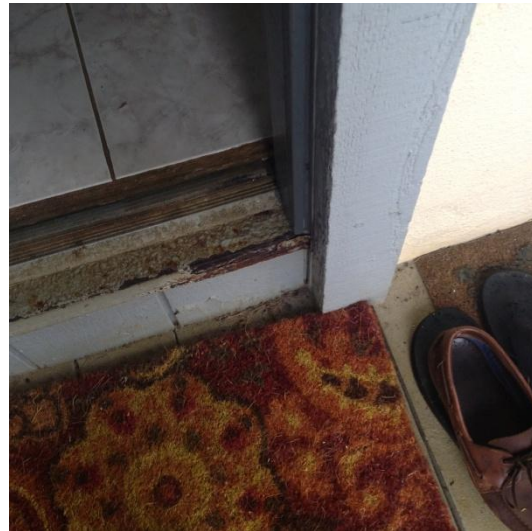
- The roofing, rain gutters, siding, trim, landscaping, stairs, decks, handrails, grounds and painting of the multifamily unit appeared to be generally in good repair and serviceable, and is maintained and managed by Hawaii First.
- A dedicated parking space was observed for the unit.
- The entry of the home faces south. The screen door did not have the automatic closing mechanism. Flashing below door threshold was rusty. These items are easily repaired by a qualified professional.

- Install closer to front screen door.
- Clean or replace flashing at front door threshold.

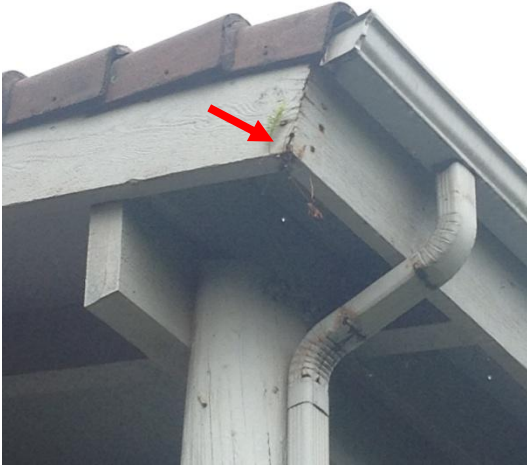
- An area on the fascia board at the north east corner second story roof showed signs of rot.

- Repair damaged roof fascia board.
- Maintain foliage close to the home.
- Remove mold like substance common to our climate on front porch face.
- Adjust and lubricate or replace sliding screen to rear lanai.

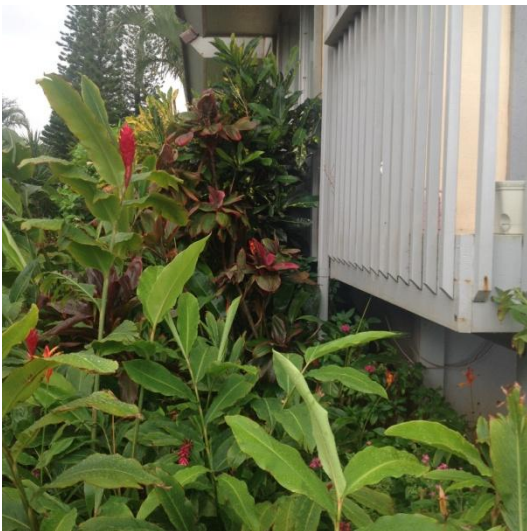
- The foliage on the east side of the home was in contact with the home in places. Foliage should be maintained to prevent contact with the home to prevent moisture and insect intrusion.

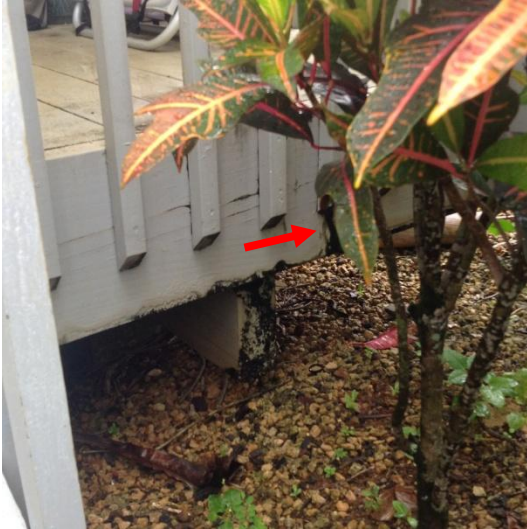
- Front porch deck and handrails appeared to be properly maintained and functional. **Mold like substance was observed on the face of the front deck structure, common to our climate.** This should be maintained to prevent rot.

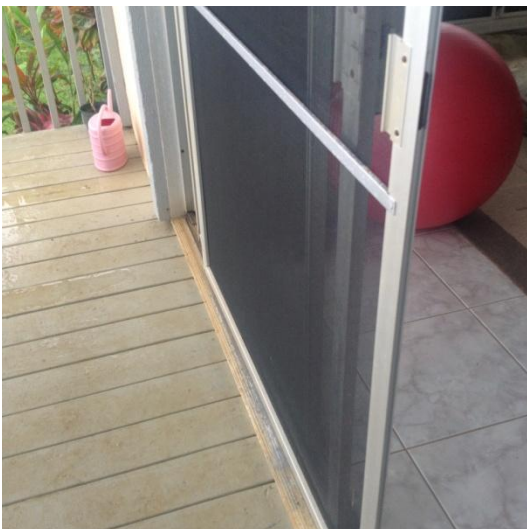
- The rear lanai off of the living room consisted of 2x decking, wood handrail and balusters, and log post to concrete piers below. All components appeared to be properly installed and functional.
- The sliding aluminum screen door to the rear lanai **did not function smoothly. Routine maintenance and lubrication is recommended.**

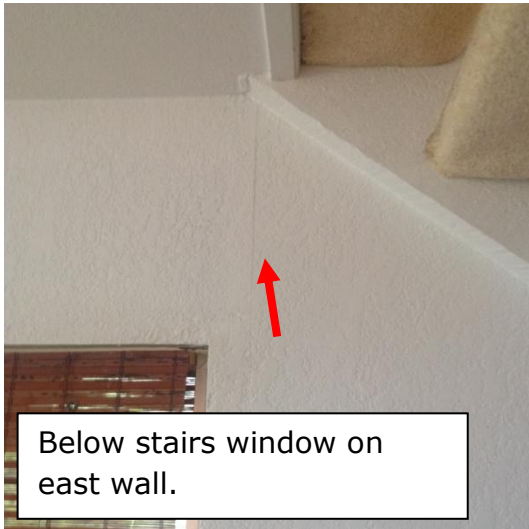
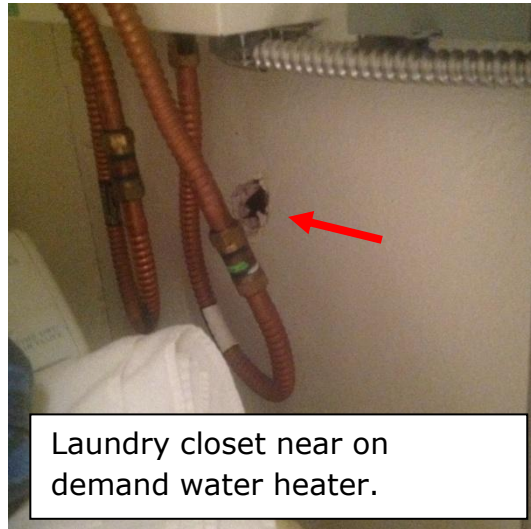
- Walls: Consists of drywall except in bathrooms. Drywall is wrapped into the window openings. **A few areas of minor to moderate damage were observed.** These areas are considered cosmetic and do not appear to be from structural issues or moisture damage. These areas are easily repaired by a qualified professional.

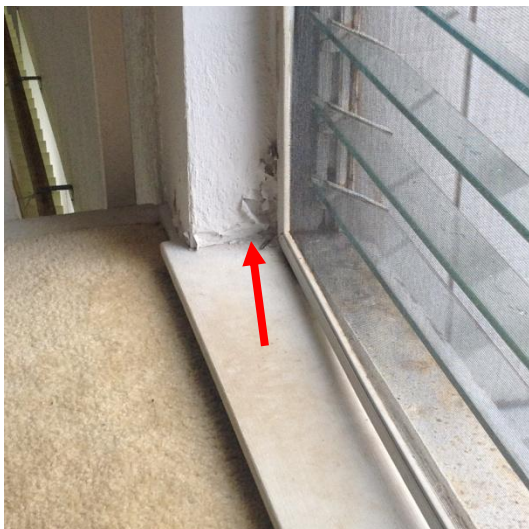
- Drywall at upstairs window on east wall shows sign of moisture intrusion, common for our climate with this type of window wrap. Repair or replace as desired by a qualified professional. The east and north sides of the home face the predominate wind direction. Care should be taken to ensure that louvered windows are not opened enough to allow moisture intrusion.

- Repair drywall at upstairs window opening. Other areas as desired.
- Repair hot water to jetted tub.
- Replace faucet screen at tub.

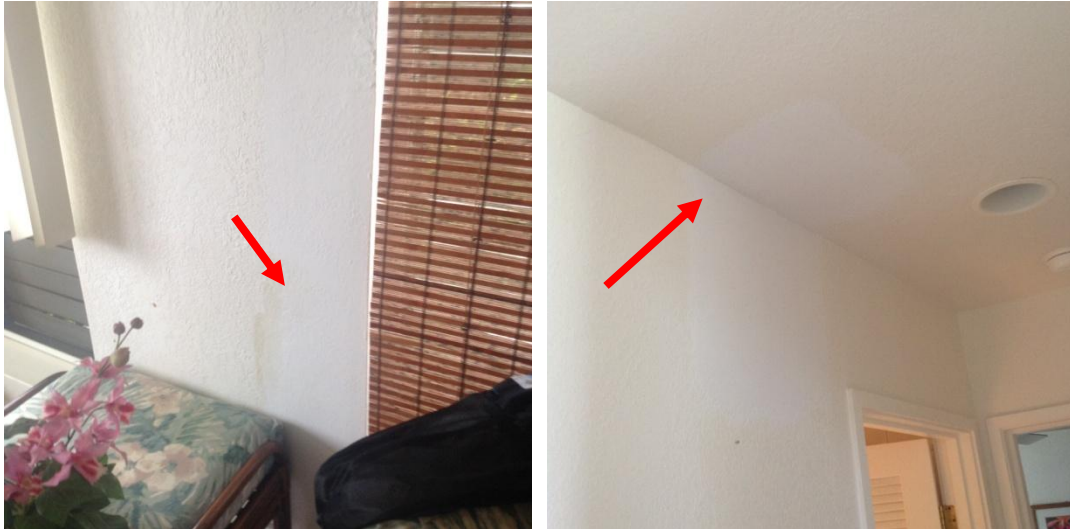
- Previous drywall repairs were noted on east wall. Also an area above the electrical panel was observed to show repairs. It is possible this area was exposed at the time the on demand water heater in the laundry closet on the other side of this wall was installed to install proper piping and connections.

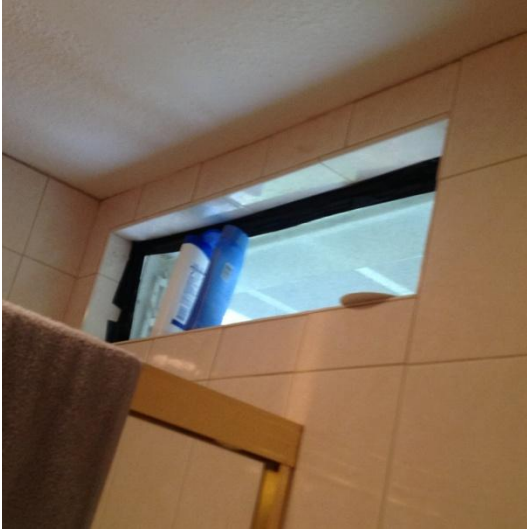
- Window screens were all present, some frames appeared to be moderately bent or ill fitting. Screen on downstairs bath window was taped in place, present occupant said it was because the screen was too small to stay in place.

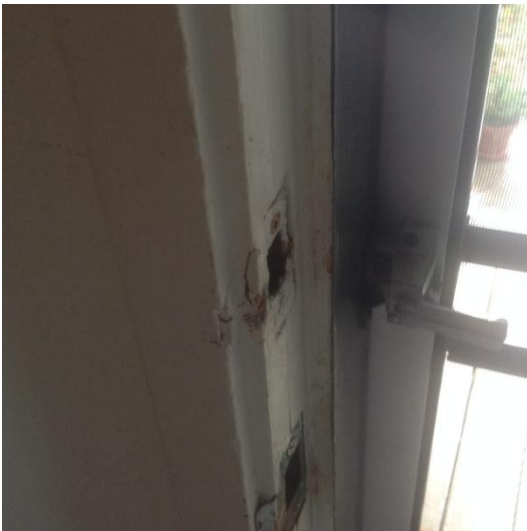
The entry door is solid core wood and functioned normally. Wood door frame was moderately damaged from dead bolt being in the locked position when door was closed.

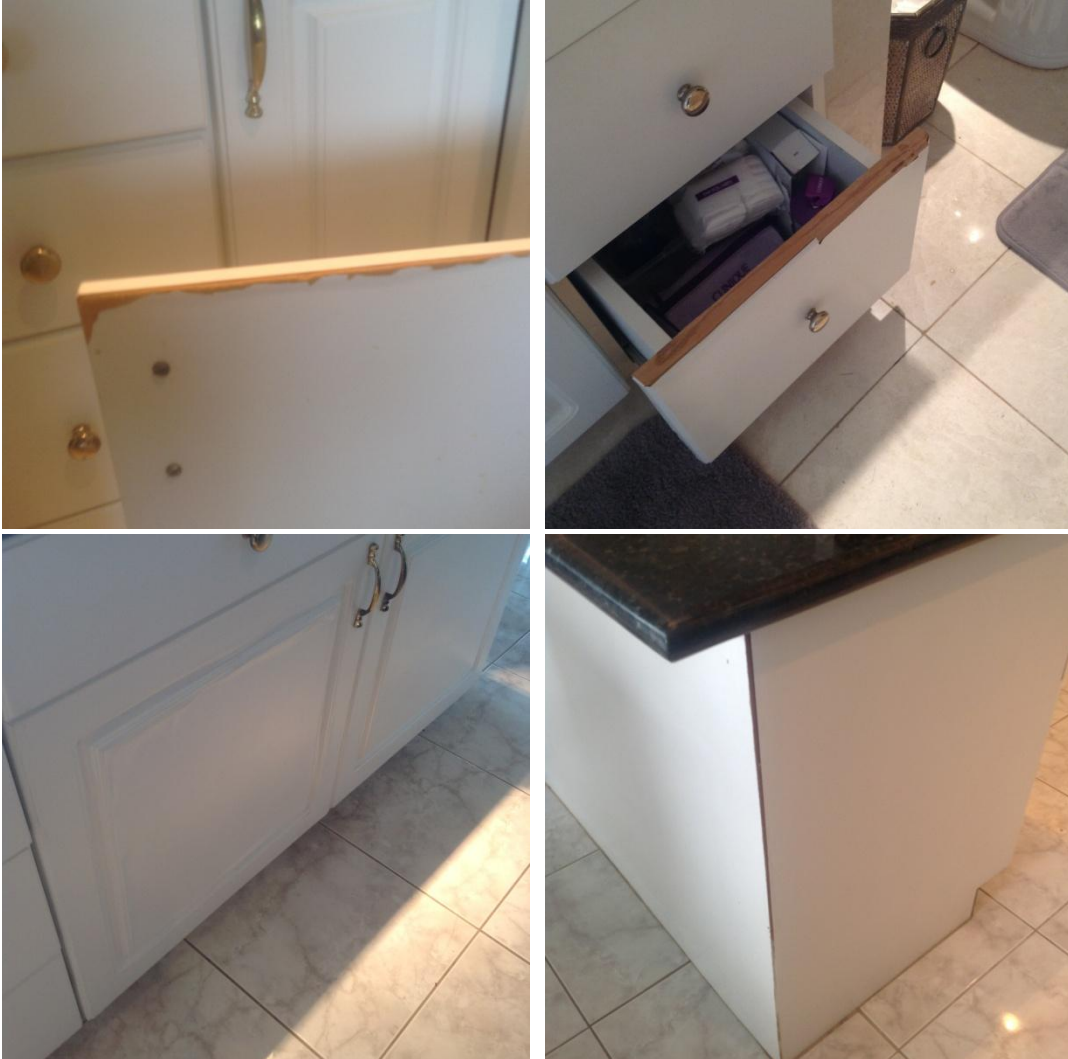
- Cabinets and countertops: All kitchen and bath cabinets doors, drawers and face frames are of wood and pressed wood components. All operated normally. Some showed signs of cosmetic damage or peeling finishes.

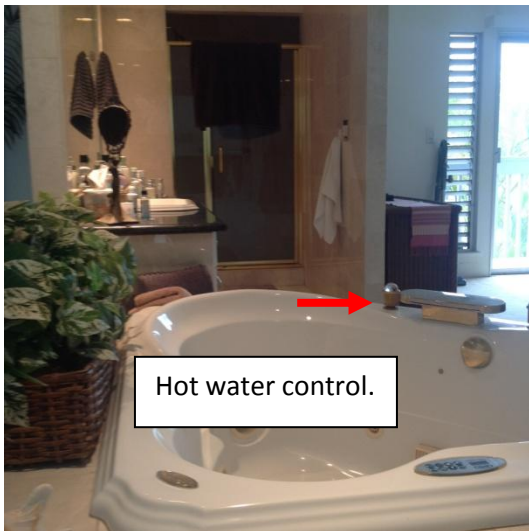
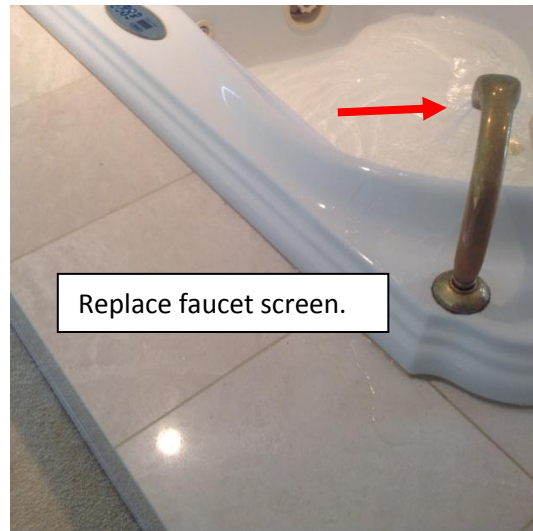
- Kitchen sink, bathroom vanities and shower heads appear to be properly installed, sealed and functional.
- Toilets were secure and operated normally.
- Jetted tub was tested and jets appeared to operate normally. The hot water was turned on and found to only trickle out of the faucet. A licensed plumber may be consulted to determine why the water pressure for the hot water control is limited. A secondary removable hand held faucet had a clogged screen and sprayed outside of the tub when in its mounted position. Screen should be replaced.
