Home Inspection Report for:
Joshua & Jennifer Hennessy

Date:
Friday, February 20, 2015 Report #022015-01

Subject Property:
5150 Kiawe St, 208 B, Princeville, HI 96722

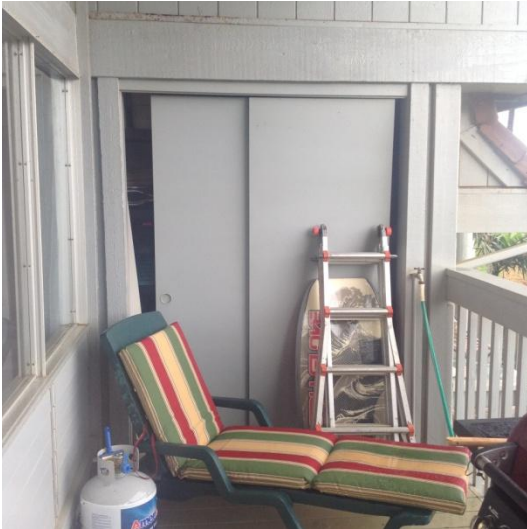
- Deck from downstairs bedroom was not accessible because of personal belongings and was not inspected.
- A storage closet was observed in the lanai area. Was not able to inspect because personal belongings were placed against doors.

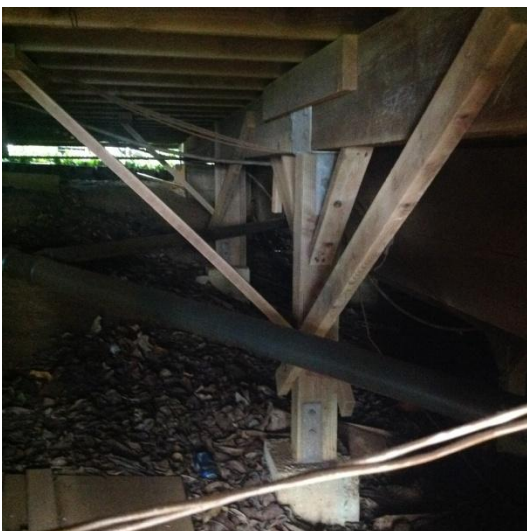
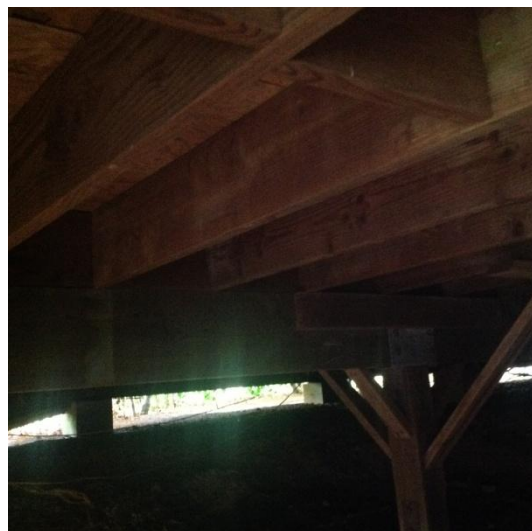
- Windows were fixed glass panels and louvered windows with glass or wood blades.
- Foundation: Home is of wood post and concrete pier construction and appeared to be properly constructed with necessary hardware.

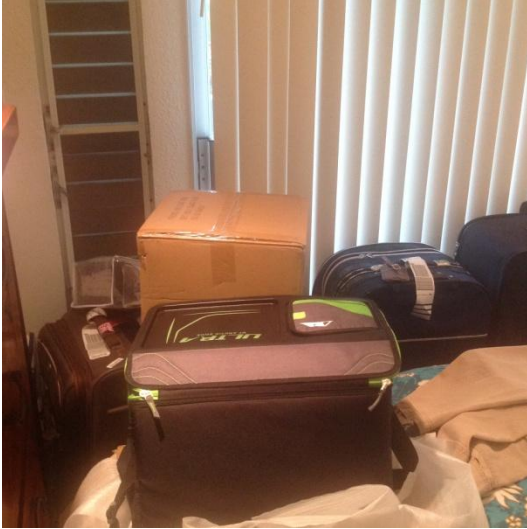
- Aluminum sliding door to rear lanai functioned normally. Aluminum sliding door to deck from downstairs bathroom was not accessible and not tested.

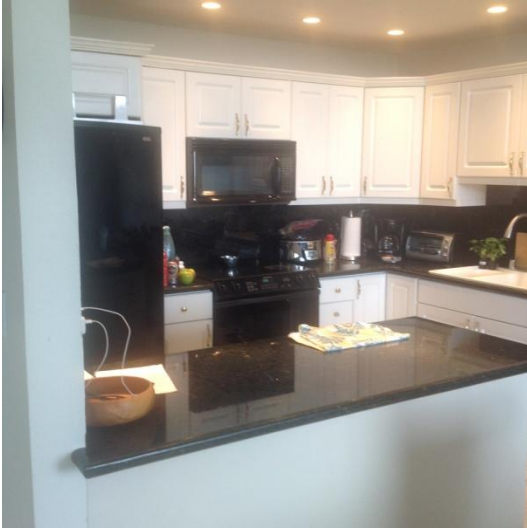
- Kitchen and bath countertops are of natural stone and appear functional.

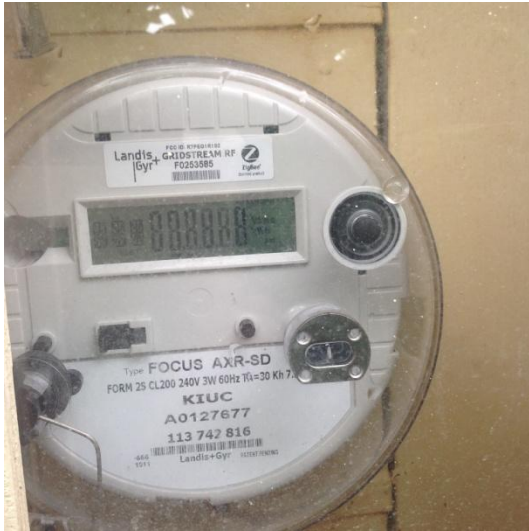
- Electrical delivery to home is underground, is publically provided and is connected to an electric meter with a 100 amp main breaker, located east wall of the unit.

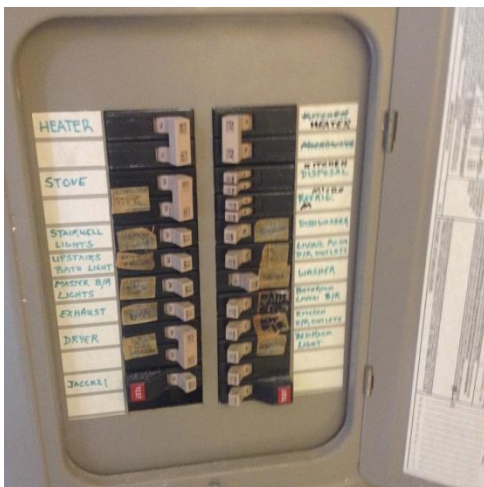
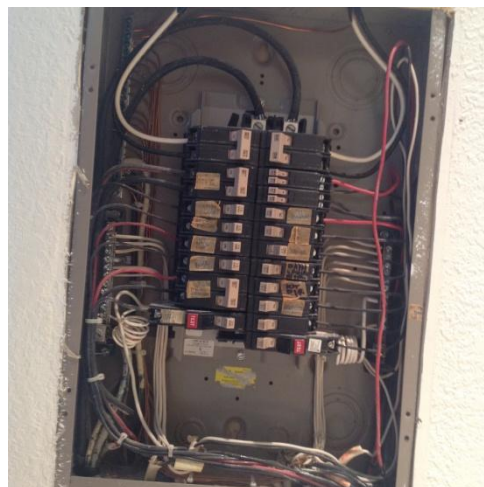
- The main load center panel is a 100 amp service and is located near the downstairs bathroom. Main circuit breaker panel appears to be properly wired and is functional. Breakers appear to be properly labeled.

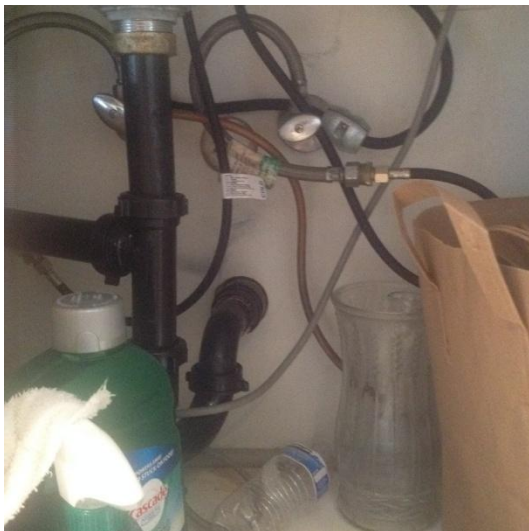
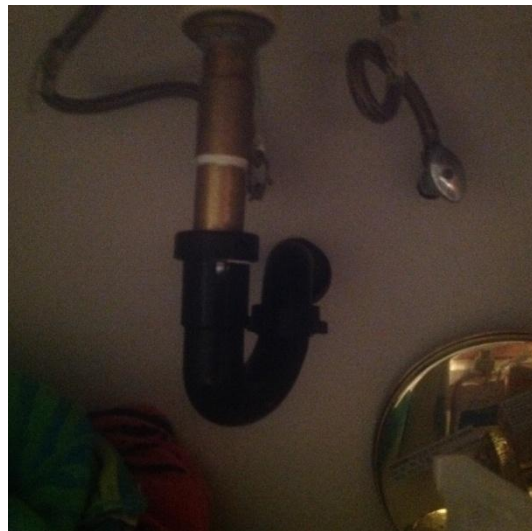
- Supply piping to the home is copper from a water meter located at the front of the property at the street. All water pipes appear to be properly installed and functional.
- Drain pipes are of PVC plastic, and appear to be properly installed and functional. All drains appeared unobstructed and operated normally.

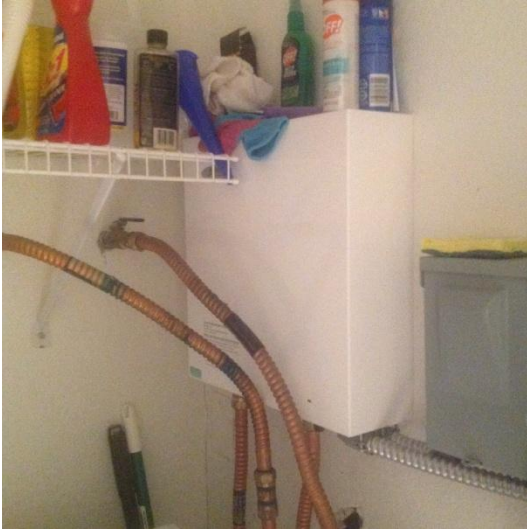
- An electric on demand water heater was observed in the laundry closet, appeared properly installed and hot water was present at plumbing fixtures.
